Absolute shocker of the week

14 August 2012

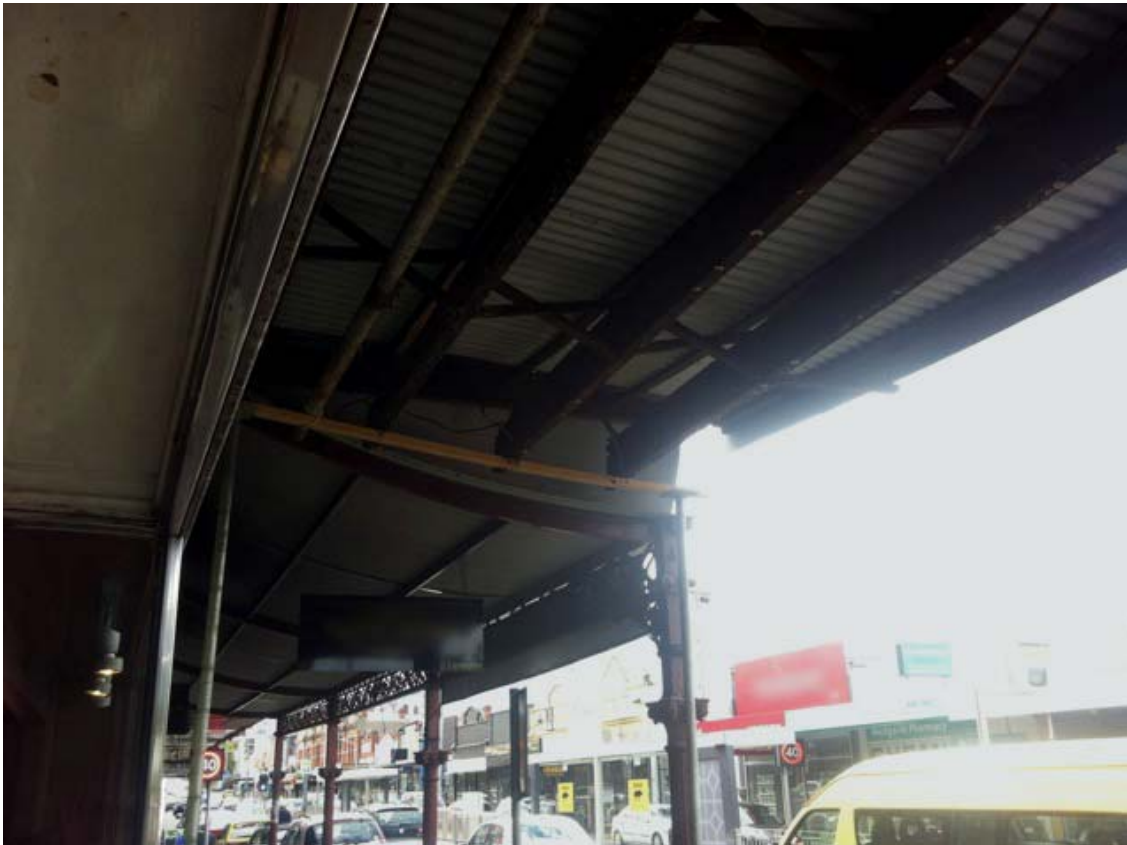
"Apparently this veranda was damaged by a truck. Notice how the 6m long 250mm x 50mm rafters are sitting on the flat 70mm x 35mm pine beam supporting by 2 unbraced temporary props. Note the curve in the pine beam and how the rafters have sagged 200mm from the now unsupported roof sheets."

Structural collapse is one of the biggest killers of construction workers. This photo clearly highlights why you need to get expert advice about how to support structures to prevent collapse.

Installing temporary supports to prevent collapse is high risk construction work and a safe work method statement (SWMS) should have been prepared and followed for the work.
