# Worksite Safety Update

## Promoting safety in roadwork

No 125 April - May 2013

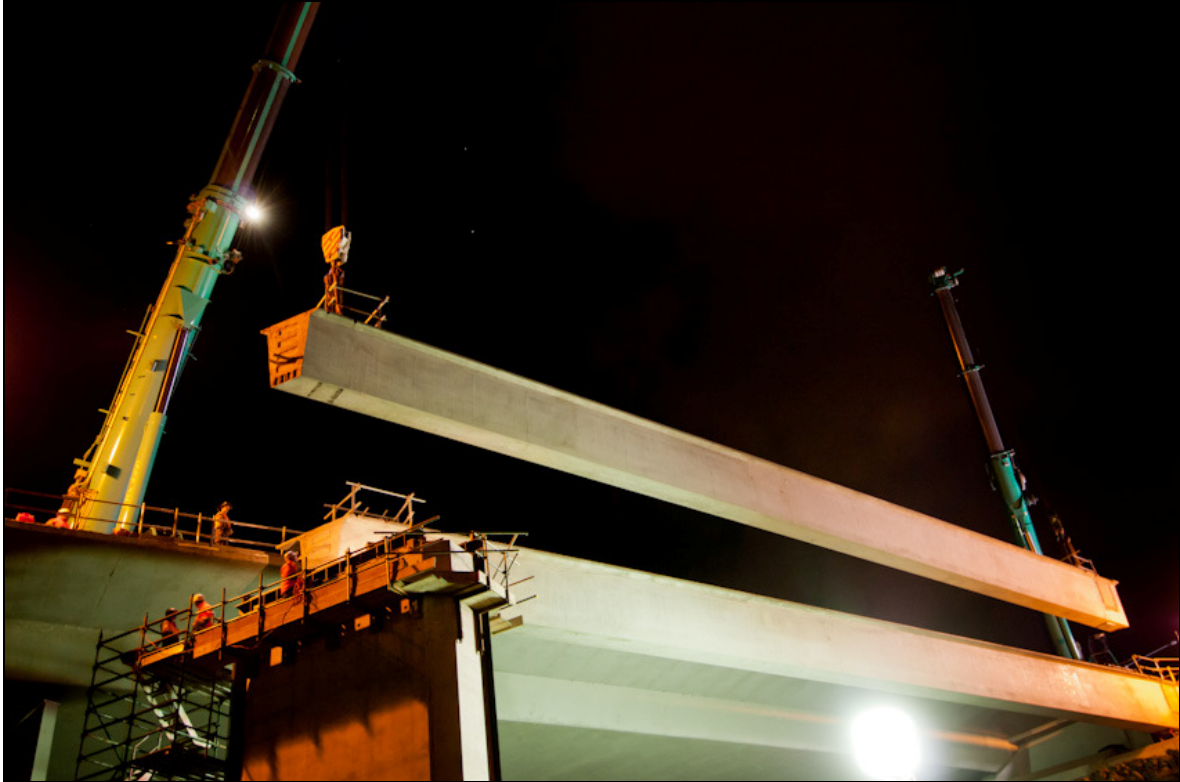
**The erection of one of the 100 tonne 45 metre long beams.**

Leighton Contractors when constructing the Tilburn Road to Furlong Road section of the M80 Ring Road Upgrade for VicRoads required oversized Super-T beams to be installed on the Western Highway overpass. Measuring 2m deep and weighing up to 100 tonnes, the 45m long beams were 5m longer than the standard largest beam. Extensive innovation was required to design, manufacture and transport the beams, position them and post-tension them together. The main safety concern was to ensure personnel were not exposed to live edges and potential for falls from height.

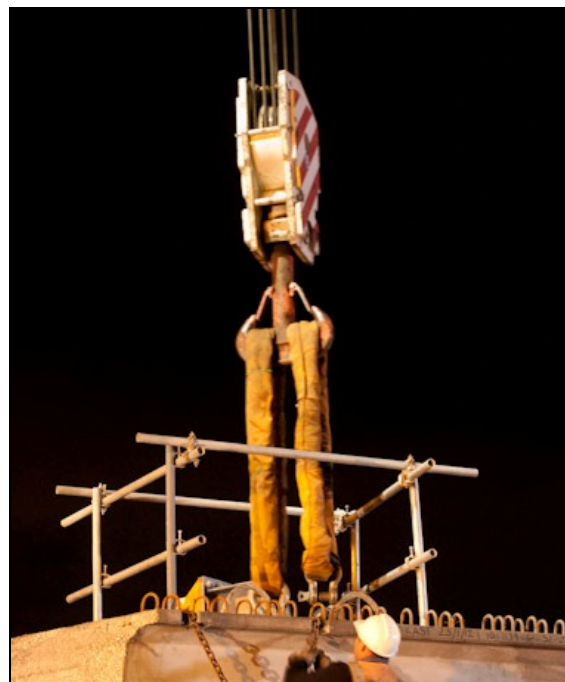
**Lifting arrangement with the wire rope lifting loops cast into the beam and handrails.**

During beam manufacture, Leighton Contractors installed handrails at the beam ends and a new proprietary wire rope loop lifting system cast into the concrete. On site, the riggers used an elevated work platform to access the protected beam end to hook up the crane sling. **This eliminated riggers having to stretch from the elevated work platform and risk manual handling injury while carrying heavy clutches or climbing onto unprotected edges.**

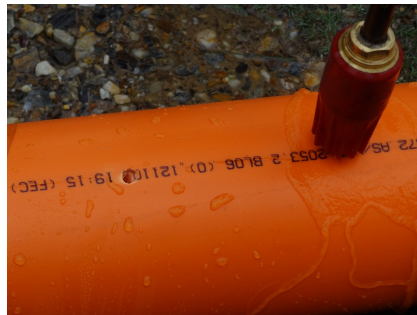
- Probing for the networks at pressure >2000PSI can cause major damage to cables and conduits. The above are two examples of probing tests carried out on the day

The non-destructive HPWJ plant can be used with a maximum operating pressure of 2000psi or 138bars to locate the network in question

The nozzle head (lance) should never be used to probe for a network

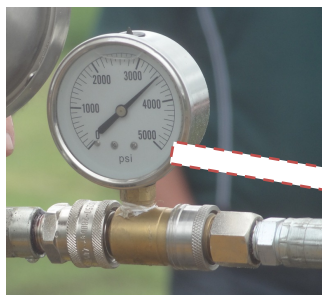
A direct buried Telstra copper cable was subject to 3500psi, sheath damaged occurred. At higher pressures the actual copper wire was exposed.

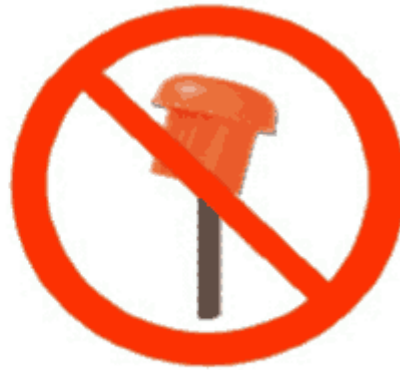
Figure 2: Typical example of an incorrectly fitted rebar-cap.

Research carried out following the incident included tests that involved dropping a 20 kg bag of sand one metre onto a vertical reinforcement bar. This showed that standard rebar-caps provide little, if any, protection against impalement on reinforcement bars should a person fall against them, even for a fall on the same level. Any protection offered by the rebar-caps, no matter how slight, was greatly reduced if they were the wrong size for the bar or were incorrectly fitted (see Figures 1 and 2 below).

- use rebar-caps offering some level of protection from impalement
- use the correct rebar-cap for the size of the bar
- fit rebar-caps properly in accordance with the supplier's instructions
- check the condition of the rebar-caps, especially for deterioration from exposure to ultra violet light, and
- regularly check that the rebar-caps are still in place and correctly fitted.
