# HSE ALERT/LESSON LEARNED

## ALERT/BULLETIN # 002

### High Winds Dislodge Perimeter Screen

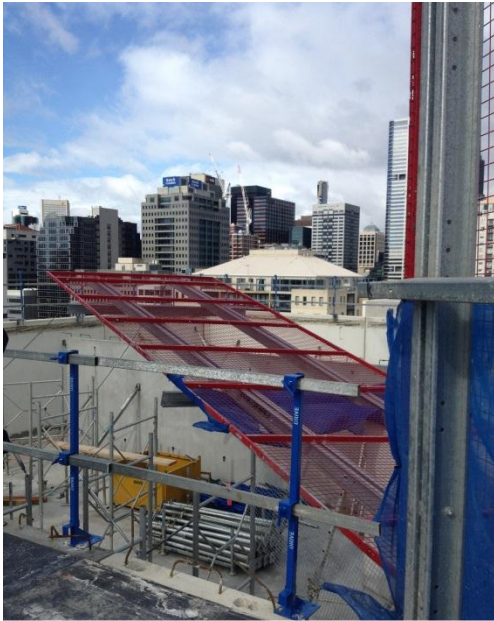
Figure 1. Dislodged Screen

| <p><b>Summary</b></p> | <p>The top seven [7] metres of a fourteen [14] metre high perimeter screen dislodged from its support base during high winds when two [2] connecting “Z bars” sheared, causing the screen to fall into the construction site. The screen remained connected to the structure of the building via the push-pull props as displayed in Figure 2. No one was injured as personnel had relocated from the top deck due to the high winds.</p> <p>In the days leading up to the incident, high winds had been experienced. At the time of the incident a severe wind gust exceeding 206k/m per hour (56m/sec) struck the CBD area of Melbourne – this is cyclone speed.</p> <p>The site was evacuated and the screen temporarily made safe until it could be safely removed from site.</p> <p>Prior to recovering the screen, the remaining screens on site were inspected by the temporary engineer and additional strapping was placed around the shear key to provide additional support in preventing uplift.</p> <p>A recovery method was developed and the screen safely retrieved.</p> |

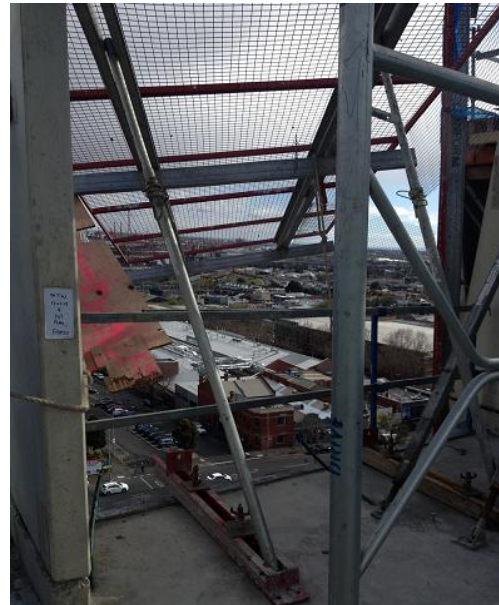
Figure 2. Screen stabilized by push-pull props

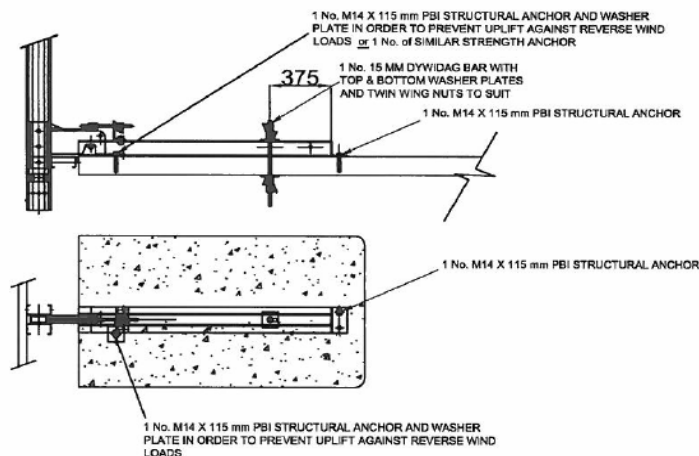
| <p><b>Further Information</b></p> | <p><b>Screen Design Detail</b></p> <p>As illustrated in Figures 3 &amp; 4 the shear key bracket provides vertical support to the screen and the Z bars provide a horizontal connection to the shear key which sits on support needles, stabilized by push-pull props.</p> <p>A post incident inspection of the screen, confirmed that the screens were installed in accordance with the engineered drawings.</p> <p>The perimeter screens are not generally designed or rated to withstand cyclone load winds unless specifically required. However calculation on the screen confirmed that the perimeter screens at the project were designed to withstand the wind loads on the day of the incident.</p> |

**SUPPORT BRACKET FIXING DETAIL**

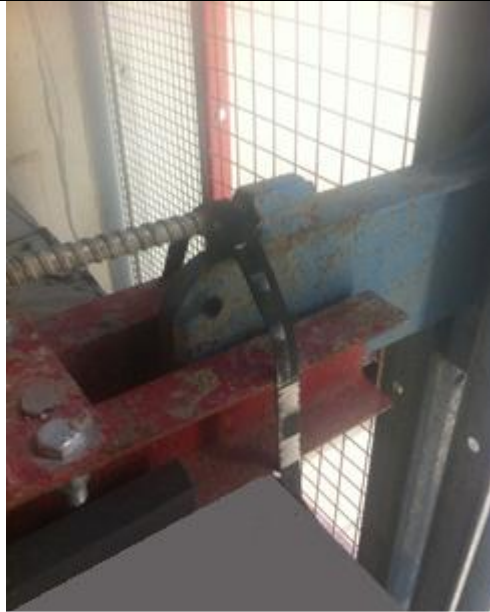
Figure 5. Strapping around the shear key

To provide extra support to the perimeter, temporary metal strapping over the shear key and onto the main support bracket as illustrated in Figure 5 should occur; this should prevent unnecessary bending on the Z bars in use.

Further to this a simple captive bracket is being designed to be installed over the shear key in lieu of the metal strap.
