## Absolute shocker of the week

4<sup>th</sup> Mar 2014

### What a corker!

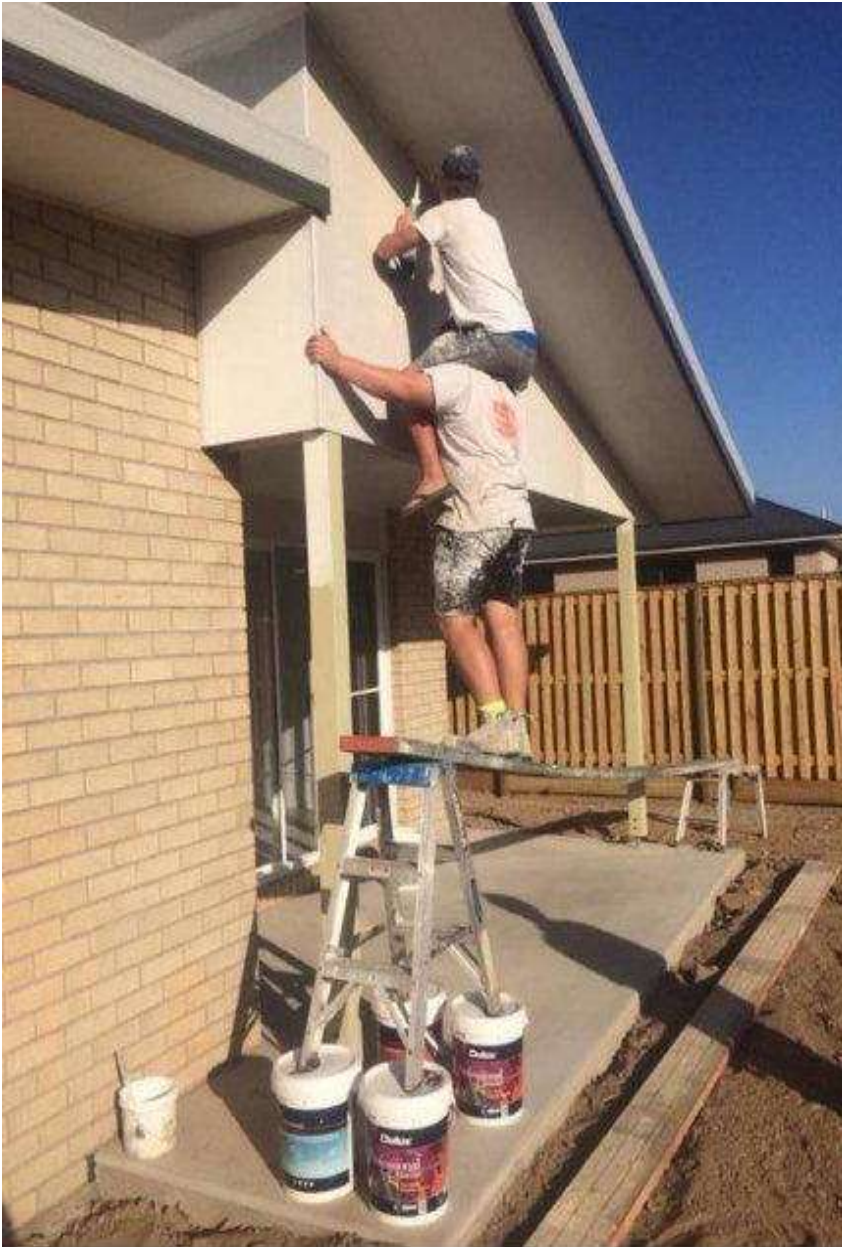
This week we see a couple of budding onsite gymnasts practicing their routines for the 2016 Rio Olympics.

The balance beam has no place on a construction site.

The apparatus these painters are using are not up to scratch:

- working platform is not two planks wide and is not level
- working platform has an excessive span
- stepladder is precariously balancing on the plastic lids of paint drums
- lack of fall protection ( and probably a safe work method statement) for working at heights greater than two metres
- and let's not forget the thongs.

If they slip off the plank or stuff-up their 'dismount' somebody may get more than a simple groin strain!
