Absolute shocker of the week

17 December 2013

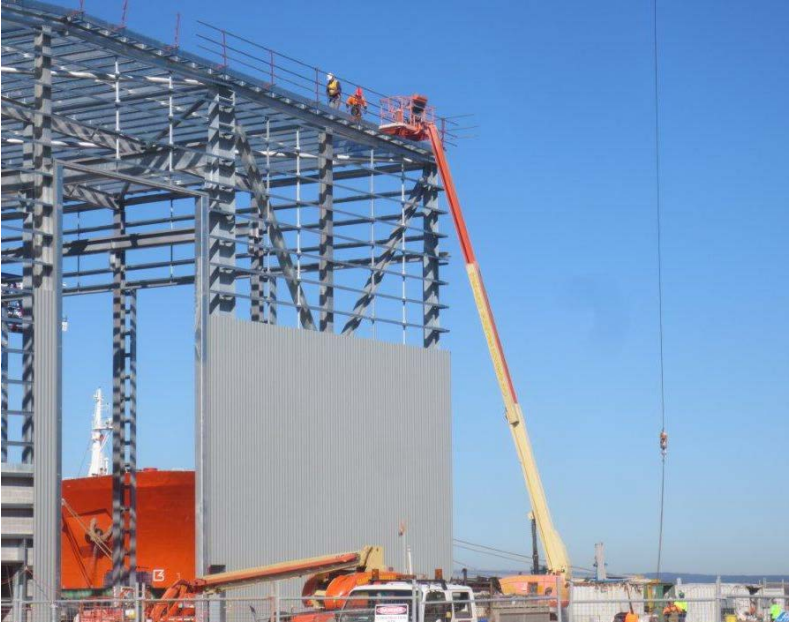
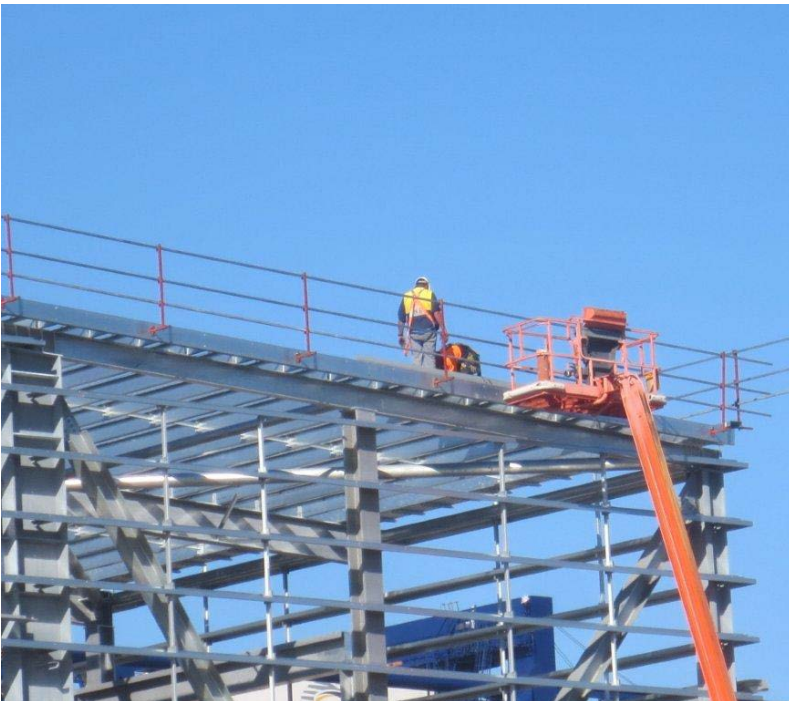
There is no acceptable reason to justify workers being on the roof of this building and walking the purlins.

A fall from this height will almost always be fatal.

As can be seen:

- the perimeter guard railing is incomplete,
- the roof safety mesh has not been installed, nor are there safety nets fitted under the roof,
- they have not even attached their safety harnesses to the roof structure to provide fall arrest.

To get on the roof they have broken the golden rule of elevating work platform (EWP) use; **NEVER** get out of the EWP basket when elevated.

Access to this type of roof should be via a scaffold stair access tower.
